**FRONT END ACCESSORY DRIVE (FEAD) BELT—
BELT NOISE, DAMAGE, AND/OR BELT COMES OFF—
VEHICLES WITH 4.6L ENGINE AND MANUAL
TRANSMISSION**

**Article No.
98-20-18**

FORD: 1996-1998 MUSTANG

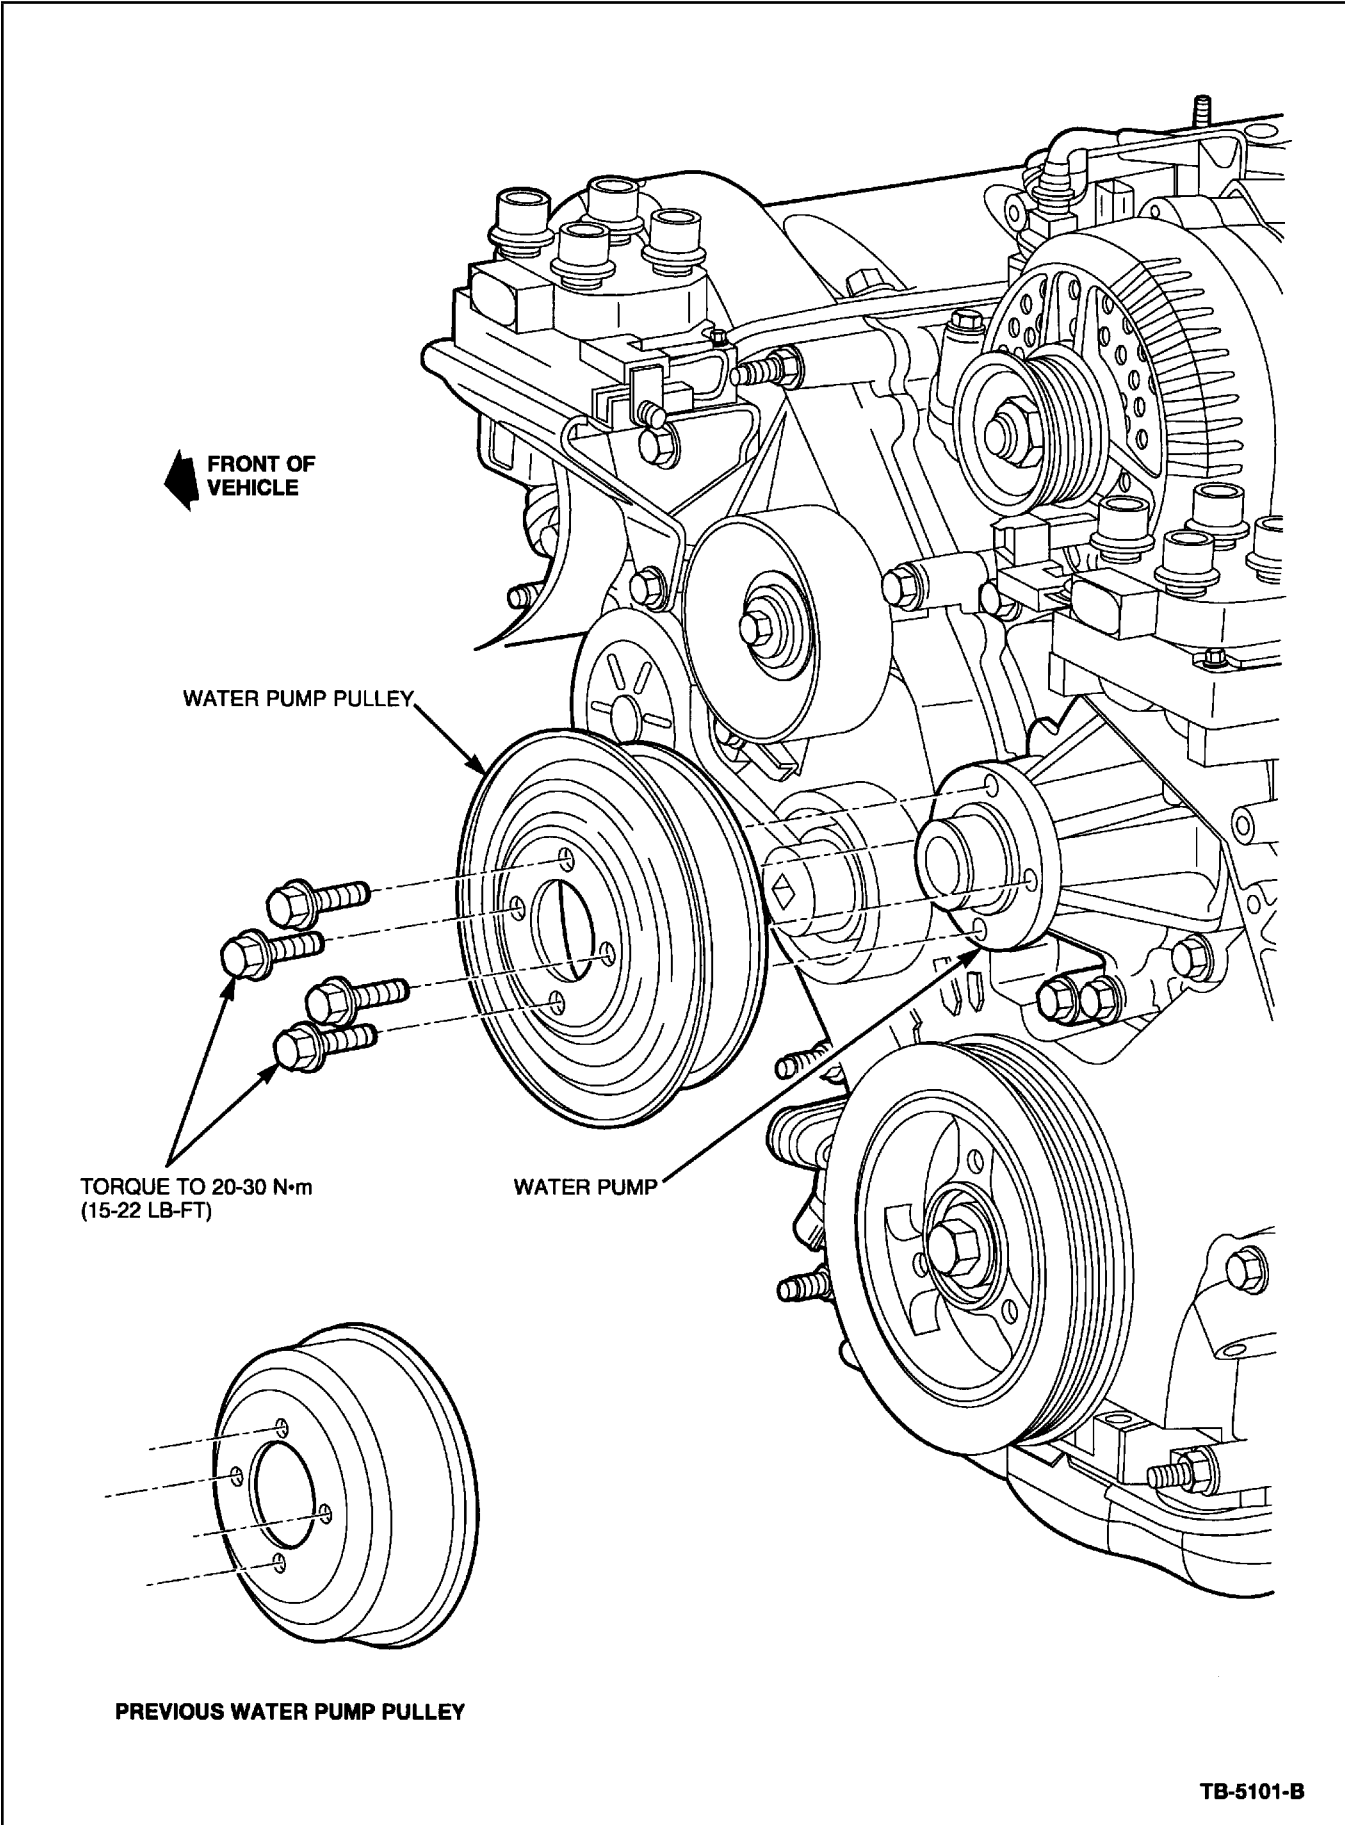
Figure 1 - Article 98-20-18

The Front End Accessory Drive (FEAD) belt may become broken or frayed and/or detach from (or roll off of) the engine. This may be caused by deceleration of the engine.

1. Remove FEAD belt and discard.
2. Verify that the vehicle has the new flanged water pump pulley installed (Figure 1). If raised flange pulley is not installed, remove and discard water pump pulley. Install new Water Pump Pulley (F6ZZ-8509-AA) and torque bolts to 20-30 N•m (15-22 lb-ft).
